SpanAir Flight 5022 Accident at Madrid on 20 August 2008

Analyst: ***Bernd Sieker***

INCIDENT ANALYSIS

On 20 August 2008, SpanAir Flight 5022 ("JK5022") lifted off from Runway 36L, briefly got airborne, rolled left and right, descended back to the grass strip at the right side of the runway, slid and bounced through uneven terrain between runways 36L and 36R, hit obstacles. It finally came to rest, disintegrated and caught fire. Most of the occupants were killed.

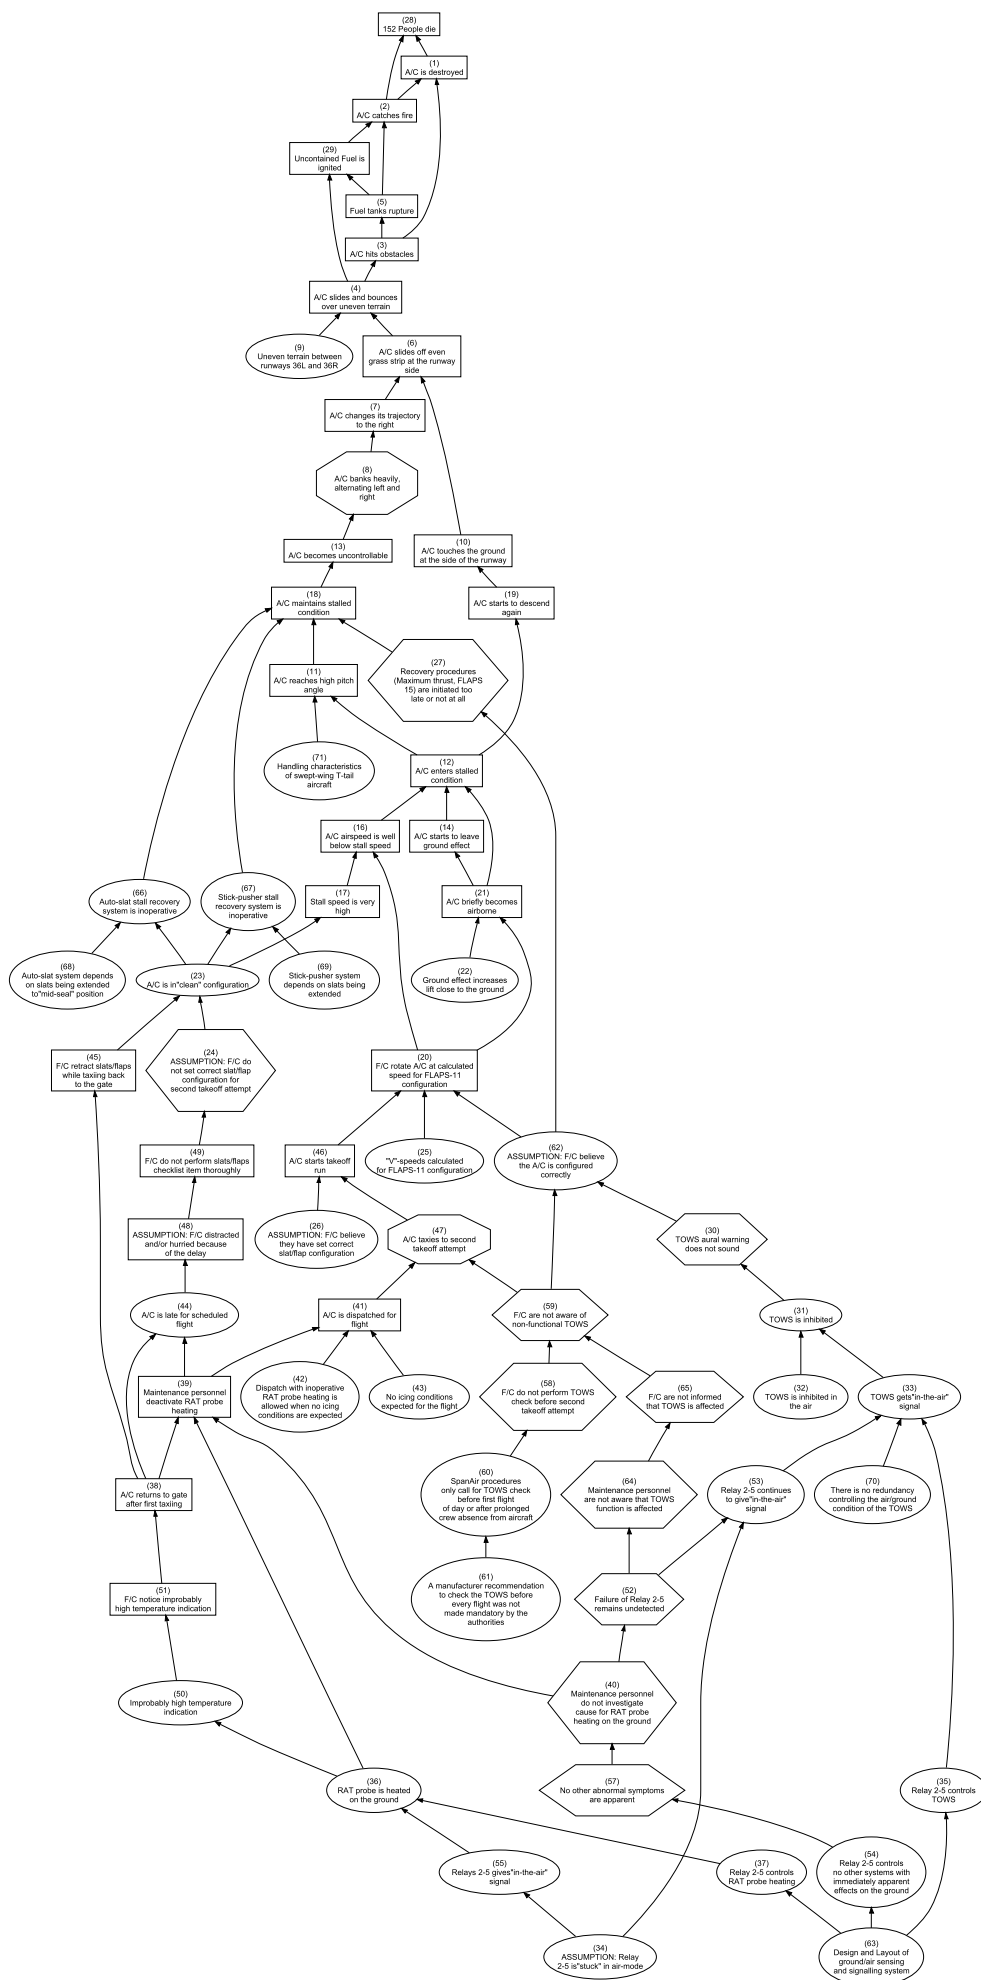
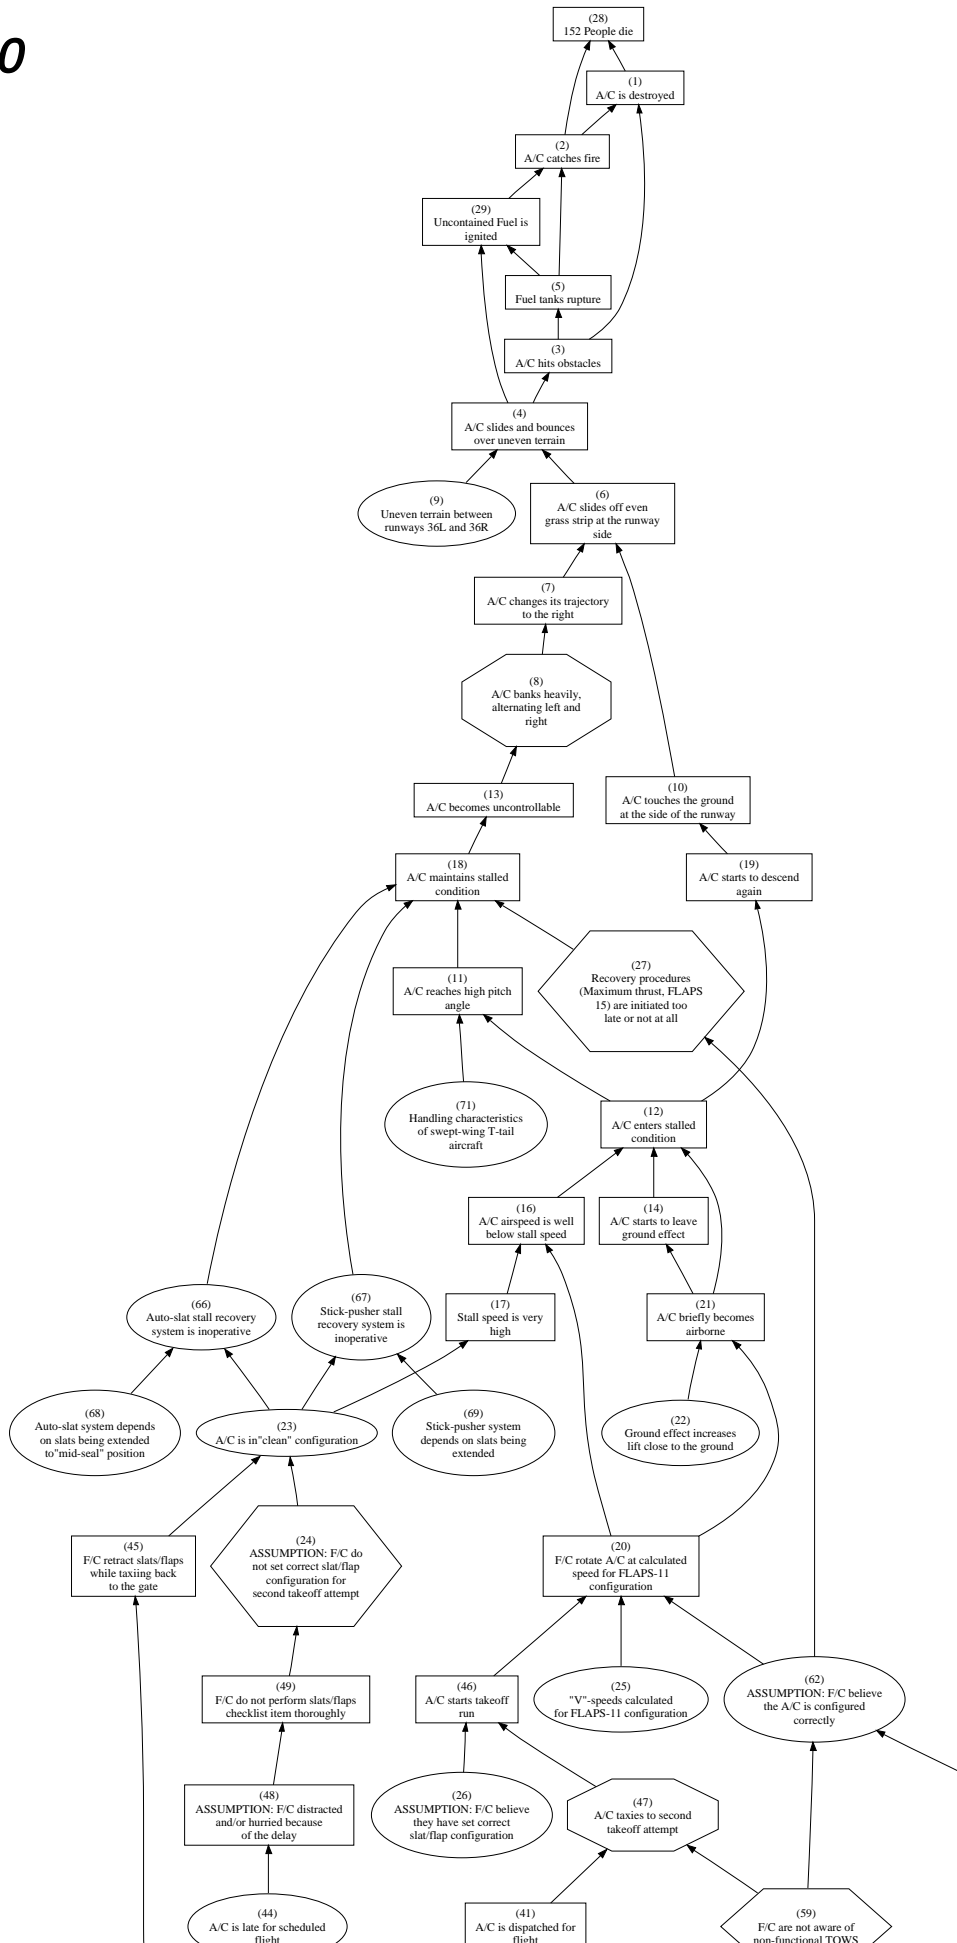
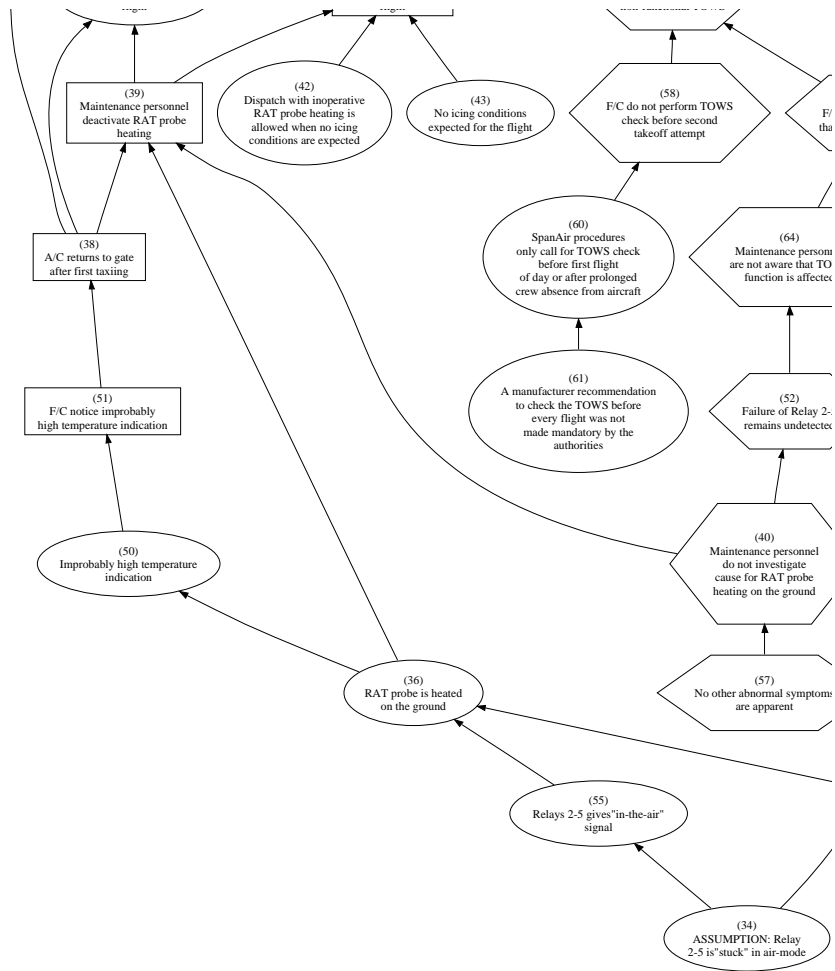
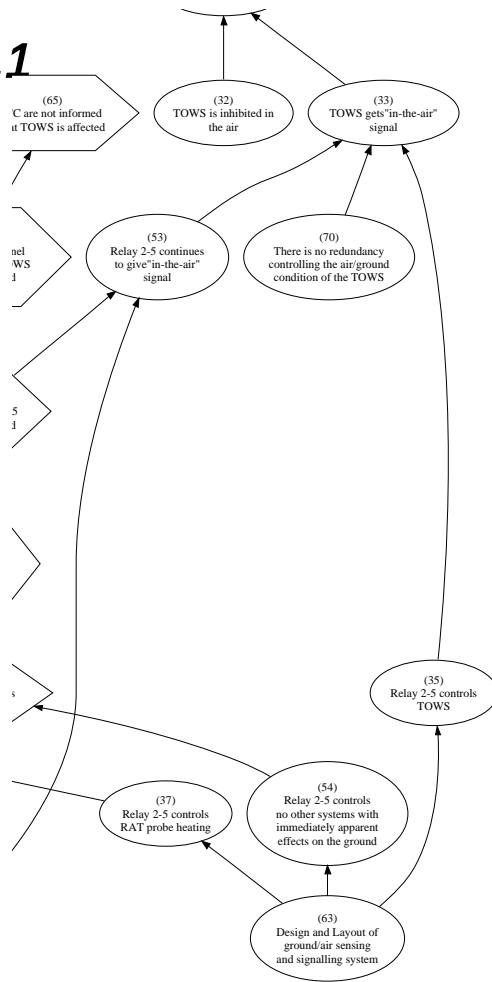
Why-Because Graph

As can be seen in the WB-Graph, at least the following design decisions were causal to the accident.

- Non-redundancy of ground-air sensing for the Takeoff Warning System (TOWS)
- Absence of a positive indication from the TOWS that the configuration is correct. Both TOWS failure and correct Takeoff configuration are indicated by silence.
- Autoslats stall-recovery system is only operative with slats extended to mid-seal position. It is inoperative with slats retracted.
- Stick-Pusher stall-recovery system is only operative with slats extended. It is inhibited with slats retracted.
