Resilience is an Emergent System Property: A Partial Argument

Peter Bernard Ladkin, Bernd Sieker

Causalis Limited & Causalis Ingenieurgesellschaft mbH

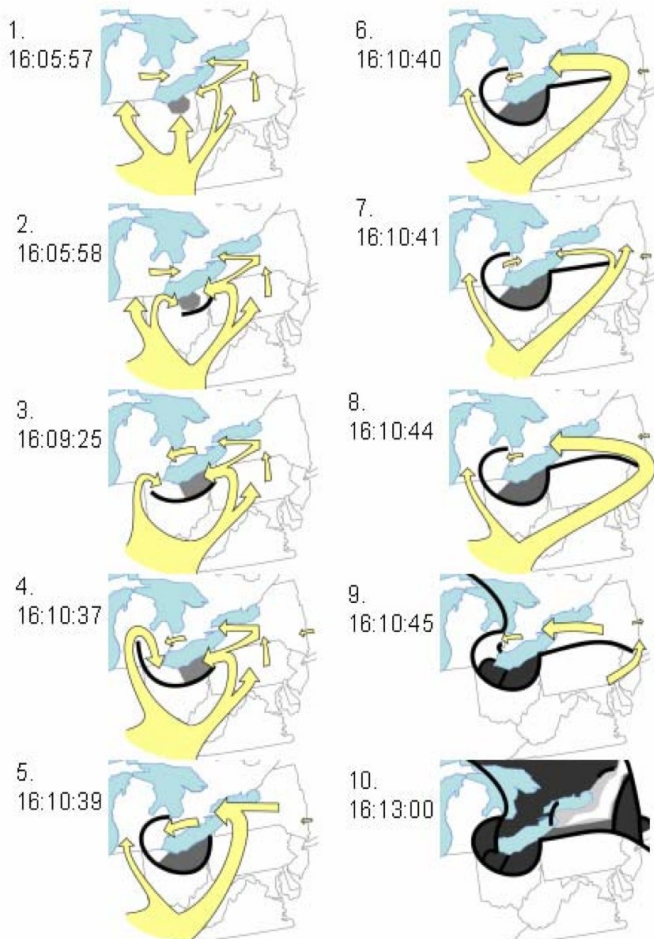
Figure 7: Power flows from immediately before the Sammis-Star trip (shown in diagrams 1 to 2) to complete system collapse (NAERC 2004, reproduced under fair use)

The areas affected by the blackout are shown in Figure 6. The power flows during progression of the blackout are shown in Figure 7.

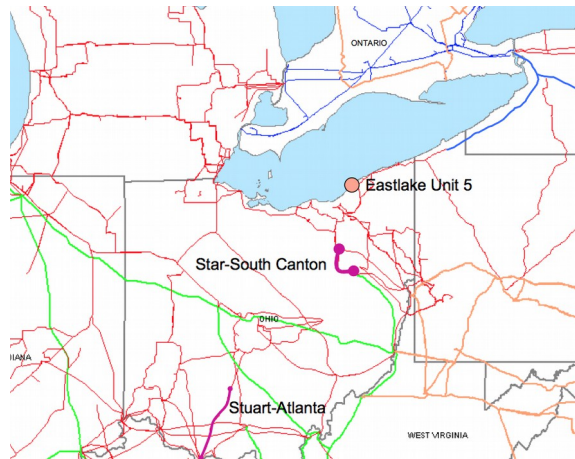
Figure 8: Initial line and plant trips (NAERC 2004, under fair use)

It follows from the above NERC-report conclusion that the most causally-significant events occurred previous to the Sammis-Star trip. We recount the significant precursor events, illustrated in Figures 8 and 9 after the text.

- At 13:31, Eastlake Unit 5, a generating station on the south shore of Lake Erie, tripped
- At 14:02, the Stuart-Atlanta 345kV line tripped. This line was not in the MISO area, so MISO had no information on it, but its non-function caused the MISO state estimator to operate incorrectly.

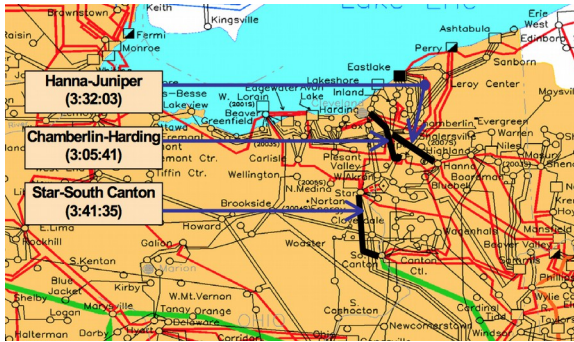
Figure 9: Three 345kV line trips (NERC 2004, under fair use)

- At 15:05, the Chamberlin-Harding 345kV line tripped and then locked out.
- At 15:32, the Hanna-Juniper 345kV line tripped and then locked out.
- At 15:41, the Star-South Canton 345kV line crossing the FE/AEP boundary tripped and locked out
- The first two of these trips were not recognised by FE because of the loss of alarm function
- These trips obviously degraded the condition of the system.
- Between 15:39 and 16:08 there was a localised cascade of tripped 138kV lines in Northeastern Ohio
 - Seven lines tripped
 - Then the Dale-West Canton line, whose tripping caused the Sammis-Star 345kV line to overload, which initiated the blackout cascade irreversibly.
 - Then three more

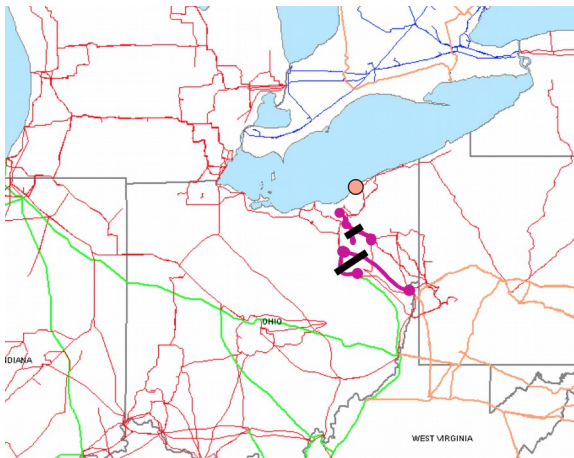
Figure 10: Cleveland and Akron supply cuts, through Sammis-Star Trip (NAERC 2004, under fair use)

The Sammis-Star trip and the resulting alteration of network flows into the Cleveland-Akron metropolitan area are shown in Figures 10 and 11.

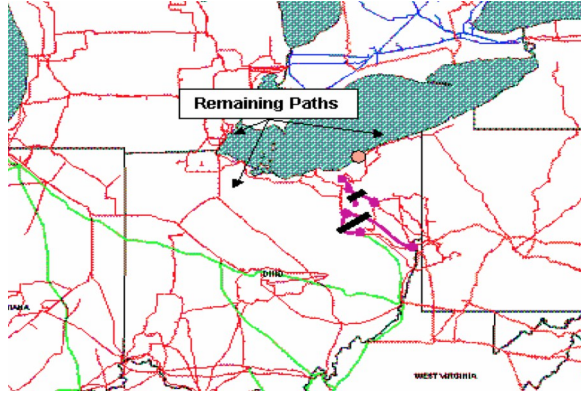
Figure 11: Remaining paths to Cleveland-Akron after the Sammis-Star trip (NAERC 2004, under fair use)

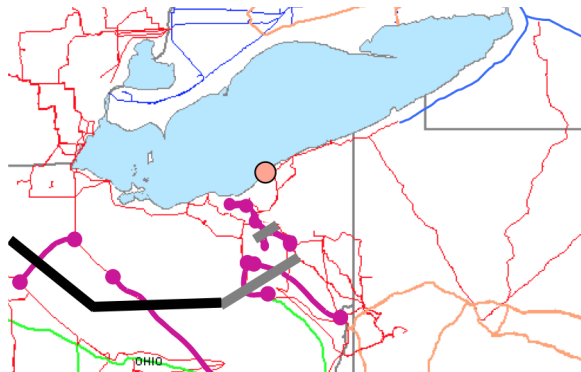
Figure 12: Ohio 345kV line trips at 3:02-3:10 minutes (NAERC 2004, under fair use)

Events progressed rapidly and, according to the NERC report, inexorably after the Sammis-Star trip. The events are pictured in sequence in Figures 12-19 below, with time in minutes after the Sammis-Star trip. Everything happened within five minutes.

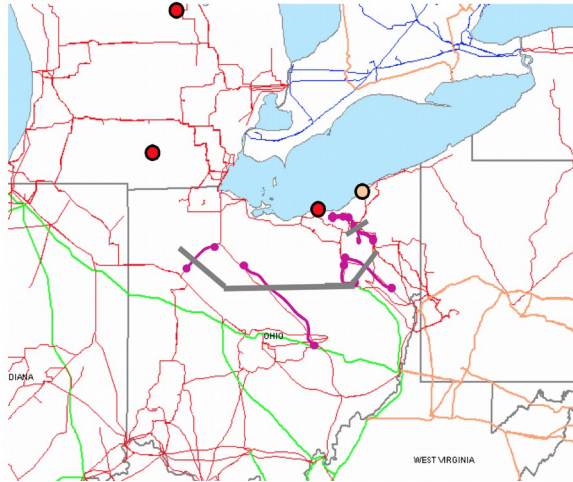
Figure 13: Michigan/Ohio plant problems at 4:39-4:41.6 minutes (NAERC 2004, under fair use)

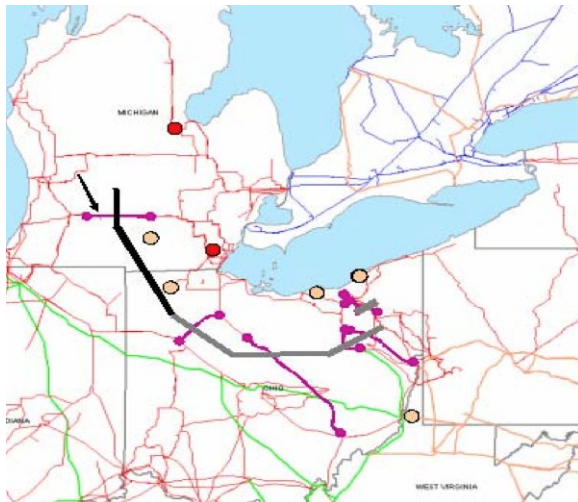
Figure 14: Eastern Michigan trips at 4:39-4:40 minutes (NAERC 2004, under fair use)

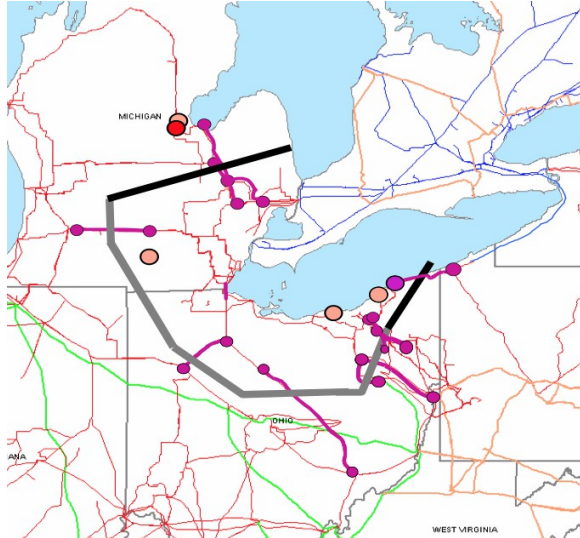
Figure 15: Michigan Trips and Ohio separates from Pennsylvania at 4:39-4:41.6 minutes (NAERC 2004, under fair use)

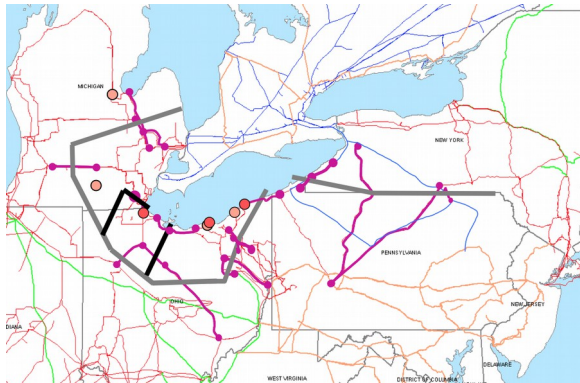
Figure 16: Cleveland and Toledo islanded at 4:41-4:49 minutes (NAERC 2004, under fair use)

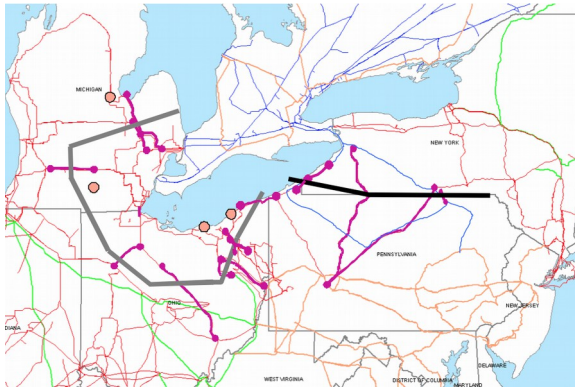
Figure 17: Western Pennsylvania separates from New York at 4:42 – 4:47 minutes (NAERC 2004, under fair use)

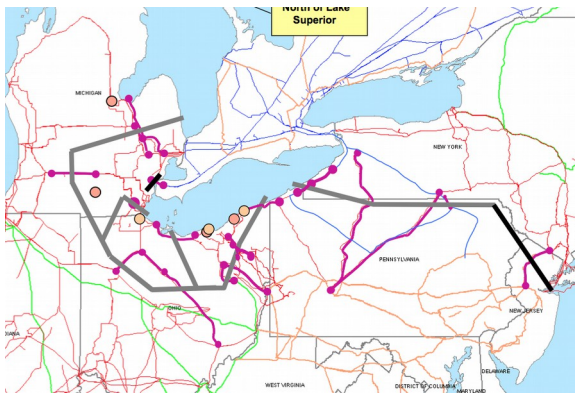
Figure 18: The North-East separates from the Eastern Interconnection at 4:48 minutes (NAERC 2004, under fair use)

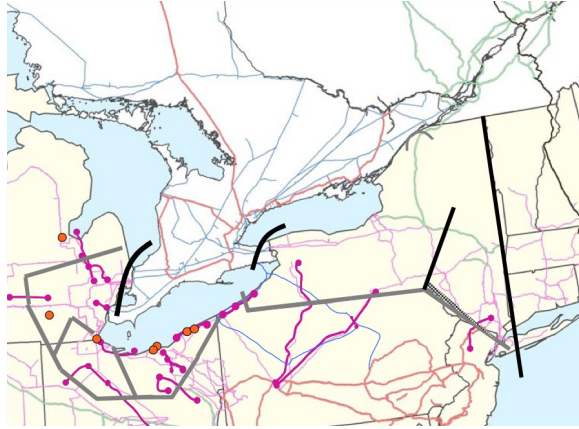
Figure 19: New York and New England separate: multiple islands form (NAERC2004, under fair use)

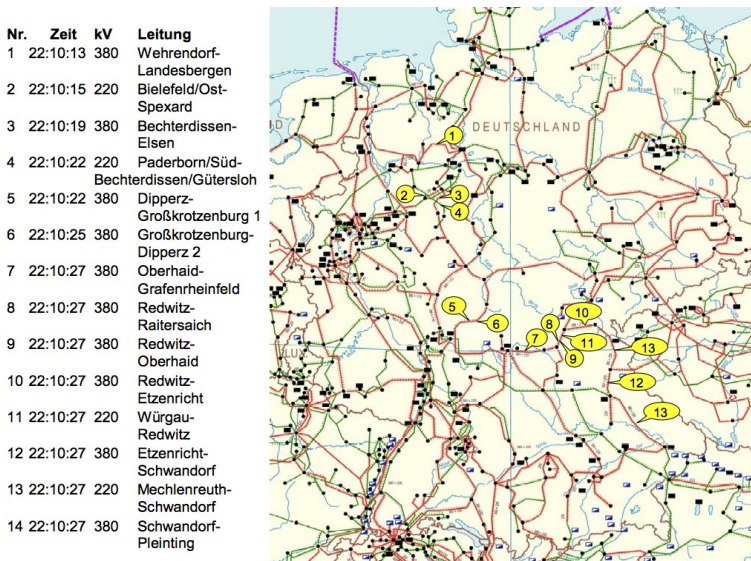
Figure 20: The first 14 lines tripped within 14 seconds (EON 2006)

Because of the rapidly-changing distribution of the current flow, other lines in Germany and other parts of Europe tripped in quick succession, illustrated in Figure 20, which caused the transmission network to be split into three parts.
